Deakin University Entry Landscaping

Storm damage leads to major reimagining of entry experience

Client: Deakin University
Location: Waurin Ponds campus, Geelong
Date: Construction completed 2017
Budget: \$350k
Roll: Design, documentation & Construction inspections

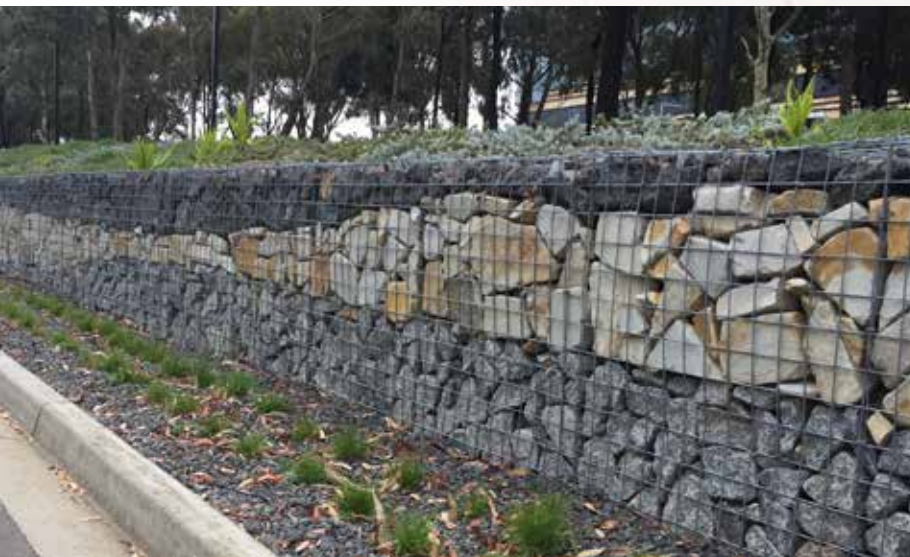
The 300m long wall features undulating bands of durable rock from three major geological periods, represented by Devonian granite, limestone spalls and bluestone ballast to create a strong, single gesture, softened itself by foliage draping from above and along the base.

The existing 20 year-old retaining wall along Nicol Drive North failed and we were approached to reimagine this important entry area to the campus. After developing a number of design options - 'Playful', 'Bookshelf' and 'Stratum' - we developed a concept that celebrates the ancient and complex geological history beneath our feet.

Working with sub-consultant structural and civil engineers Andrew Cherubin & Assic and Second Nature Engineering we documented the project for construction, ensuring that stormwater drainage was managed, and reusing the material from the old wall, resulting in a significant environmental benefit.
